BIRCH POND DAM

MA 00237

PHASE I INSPECTION REPORT
NATIONAL DAM INSPECTION PROGRAM

AUGUST 1978

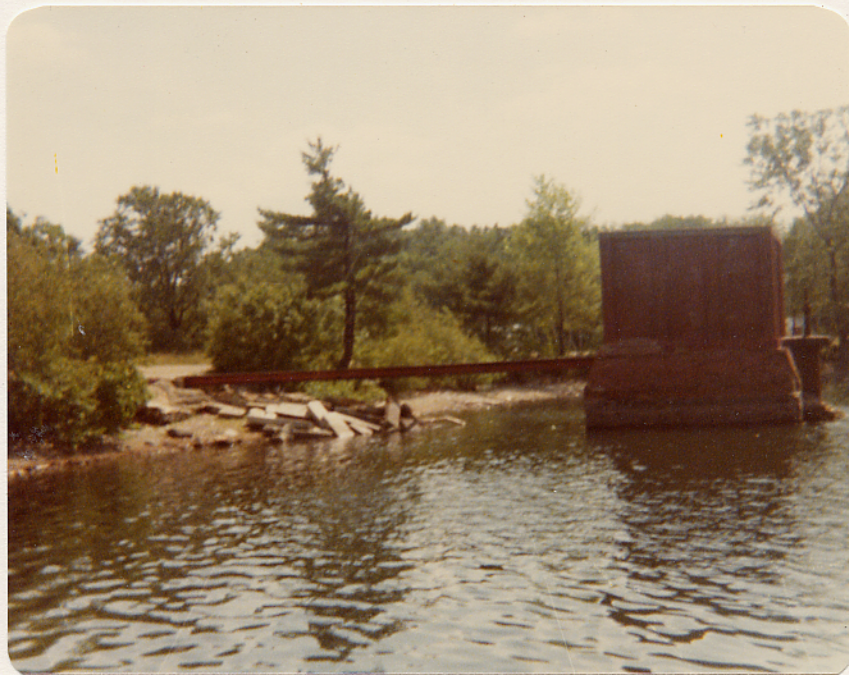
OVERVIEW PHOTO

b. Dam. The dam appears to be in poor condition. There are many areas on the upstream face where the riprap is sloughed off. In addition, the upstream slope is overgrown with vegetation. The downstream slope is eroded by an occasional motorbike trail. The embankment crest is deteriorated due to improper usage by motorbikes. Other than that caused by general deterioration, there appear to be no serious horizontal or vertical misalignments. There is no evidence of seepage through the embankment.

Additional investigations or major modifications are not necessary. Remedial measures that should be implemented by the owner within one year after receipt of this Phase I Inspection Report are described in Section 7. The dam is in serious need of extensive maintenance. The upstream face should be restored, the crest brought to true grade and surfaced, erosion on the downstream face eliminated, and the spillway cleaned and improved.
